# Test Report

Report No.:H201812253096-02EN-G1

Sample description: TD-LTE Wireless data terminal

Sample model: NLS-NFT10

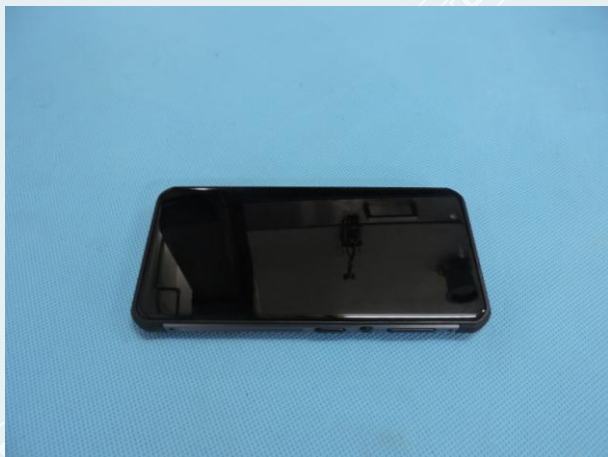
**FIG. 1-1 Pre-test appearance inspection**  
**H201812253096-0007**

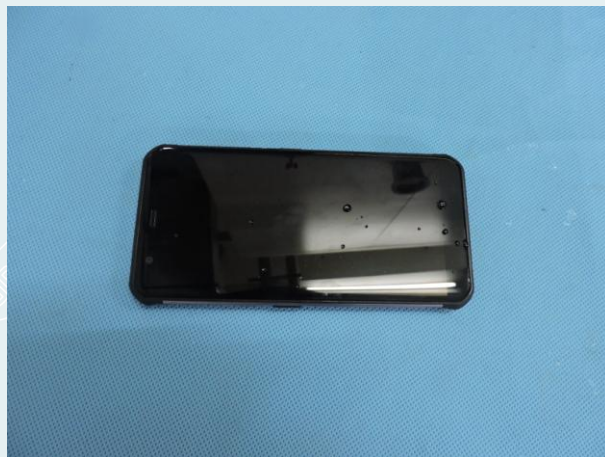
**FIG. 1-2 After test appearance inspection**  
**H201812253096-0007**

1.4.1 After IPX7 test, no water enter the EUT.

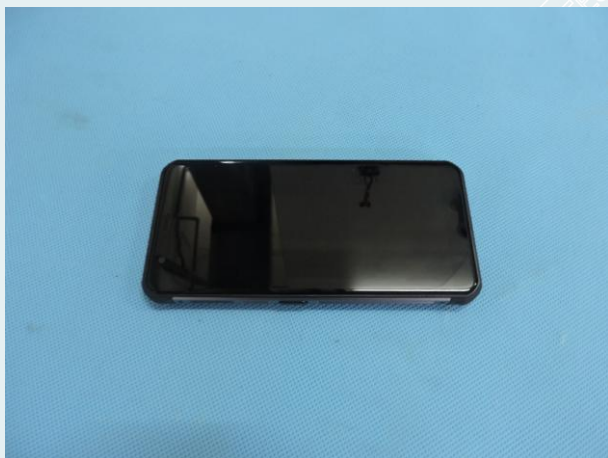
**FIG. 1-3 Pre-test appearance inspection**  
**H201812253096-0008**

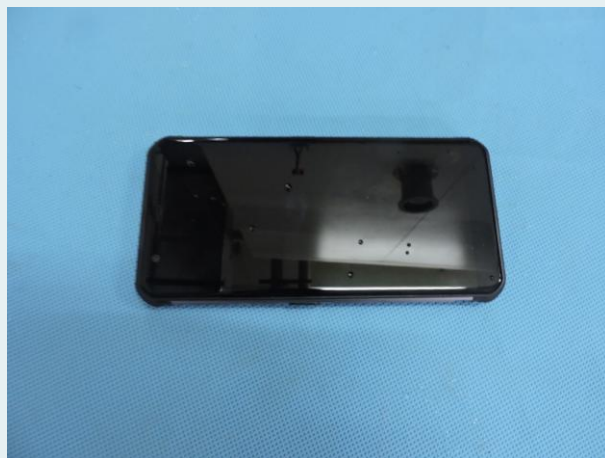
**FIG. 1-4 After test appearance inspection**  
**H201812253096-0008**

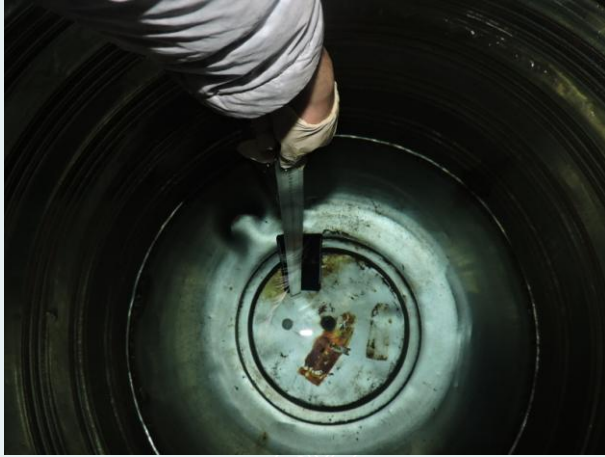
FIG. 1-5 Installation diagram

1.1.2 Immersion depth: 1m.

1.1.3 Test time: 30min.

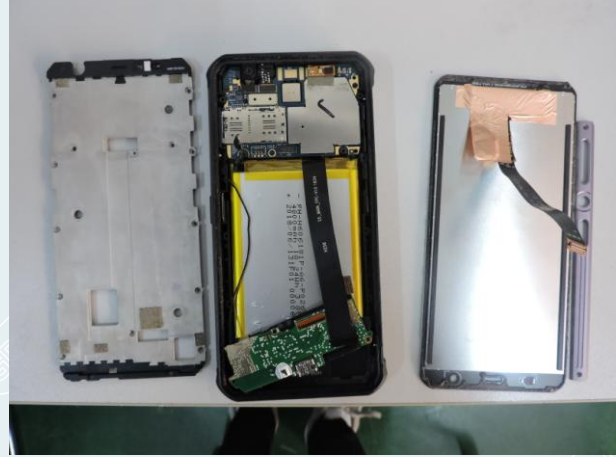
FIG. 1-6 Internal inspection

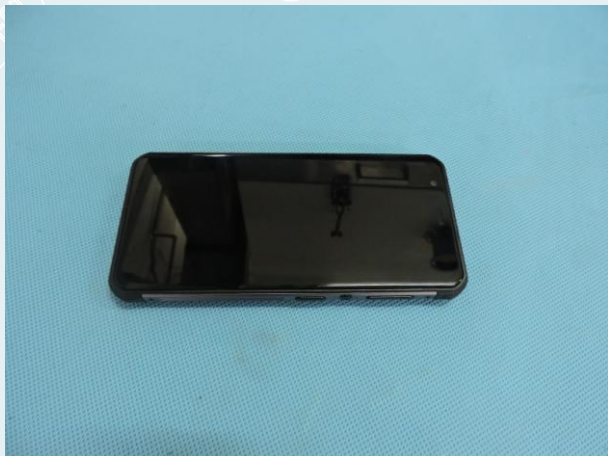
**FIG. 2-1 Pre-test appearance inspection**  
**H201812253096-0009**

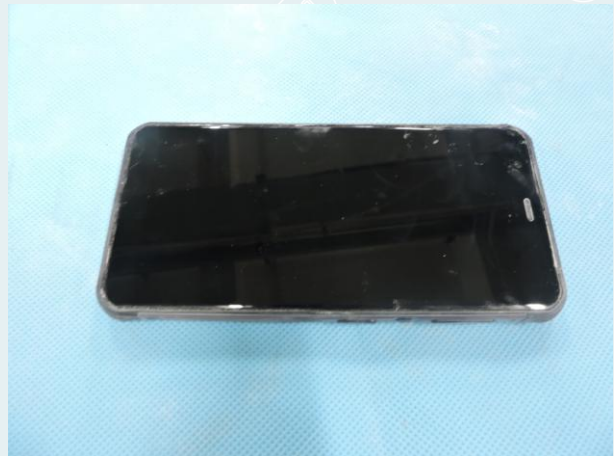
**FIG. 2-2 After test appearance inspection**  
**H201812253096-0009**

2.4.1 No dust inside the EUT.

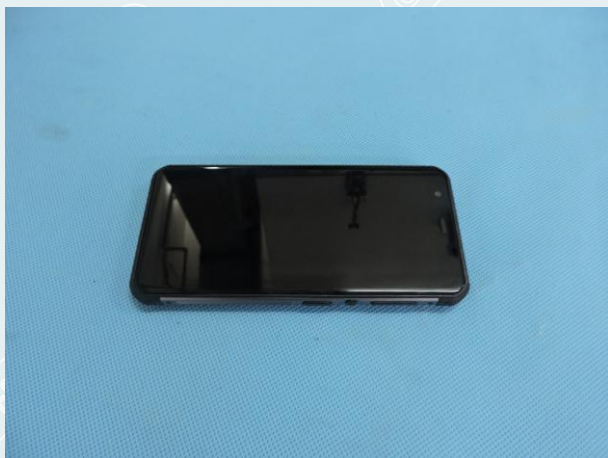
**FIG. 2-3 Pre-test appearance inspection**  
**H201812253096-0010**

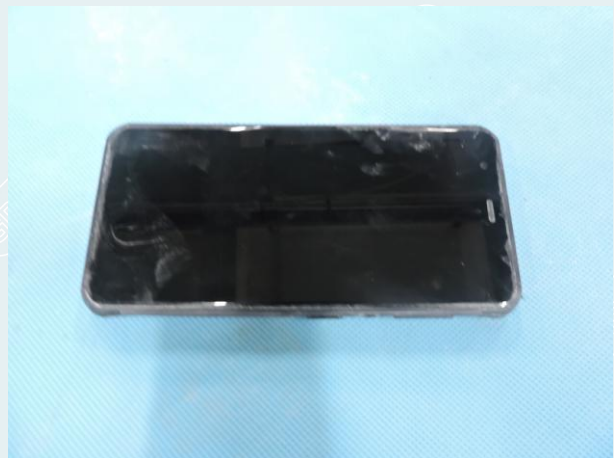
**FIG. 2-4 After test appearance inspection**  
**H201812253096-0010**

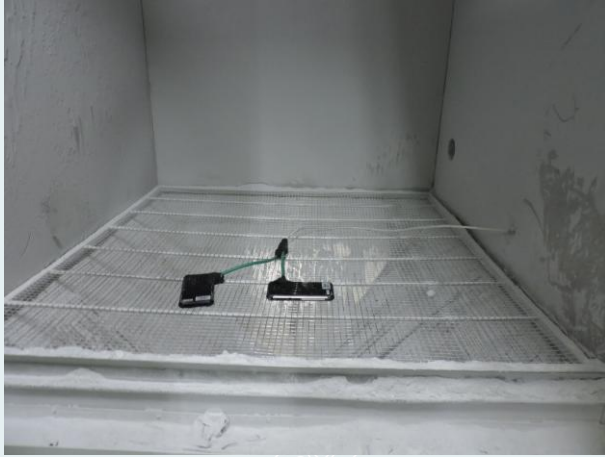
FIG. 2-5 Installation diagram

- 2.1.1 Reference standard: IEC-60529-2013.
- 2.1.2 Dust type: talcum powder.
- 2.1.3 Dust concentration:  $2\text{kg}/\text{m}^3$ .
- 2.1.4 Dust blowing method: continuous blowing dust.
- 2.1.5 Maximum pressure difference: 2kPa.
- 2.1.6 Gas extraction: 80 times the volume of the casing.
- 2.1.7 Pumping speed: greater than 40 times per hour, shell volume.
- 2.1.8 Test time: 2h.

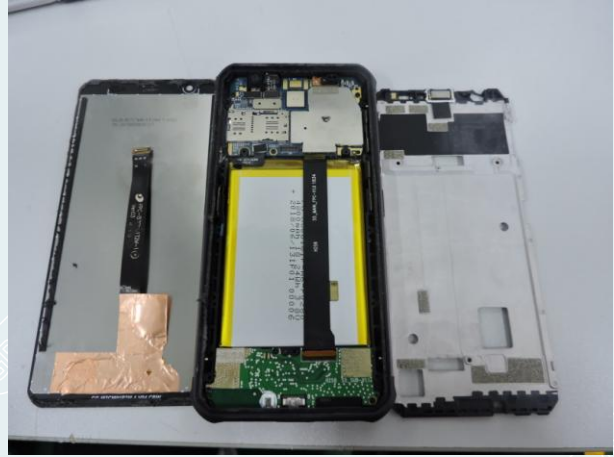
FIG. 2-6 internal inspection
