# 检测报告

## TEST REPORT

| 产品名称<br>NAME OF SAMPLE | 手持式条码扫描器<br>Hand-held Bar Code Scanner |
| 检验项目<br>TEST ITEM | 跌落测试<br>Drop Test |

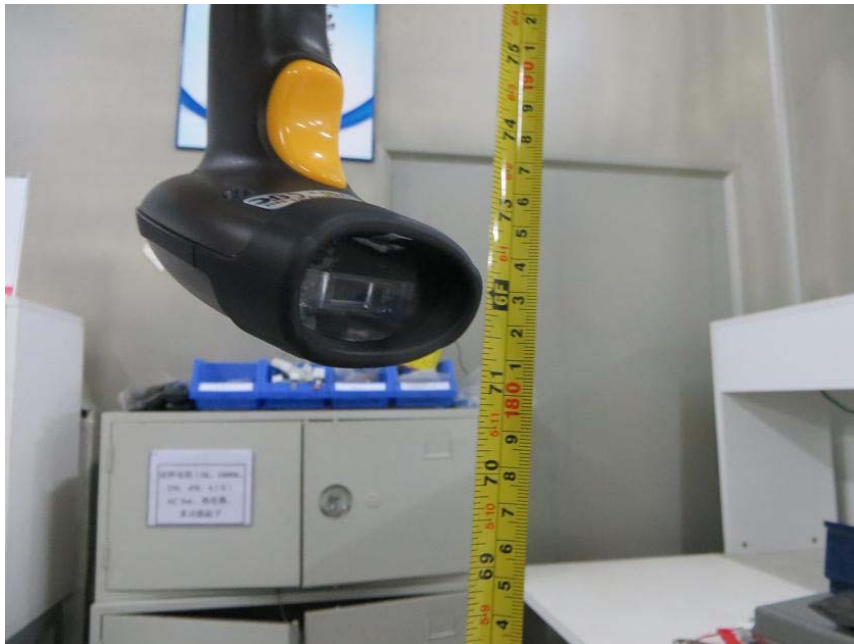
Fig.1 The view of higher

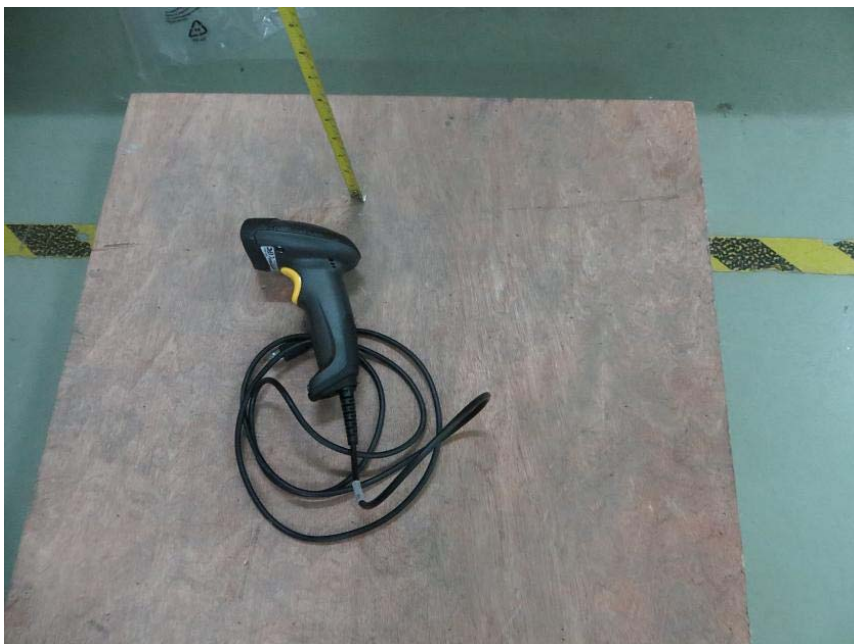
| Item<br>项目 | Test item<br>测试项目 | Standard requirement<br>标准要求 | Result<br>结果 |
|---|---|---|---|
| | Front<br>前 | dropping from 1.8m<br>从 1.8 米处跌落 | No damage<br>没有危险 |

Fig.2 Test result of drop from Front

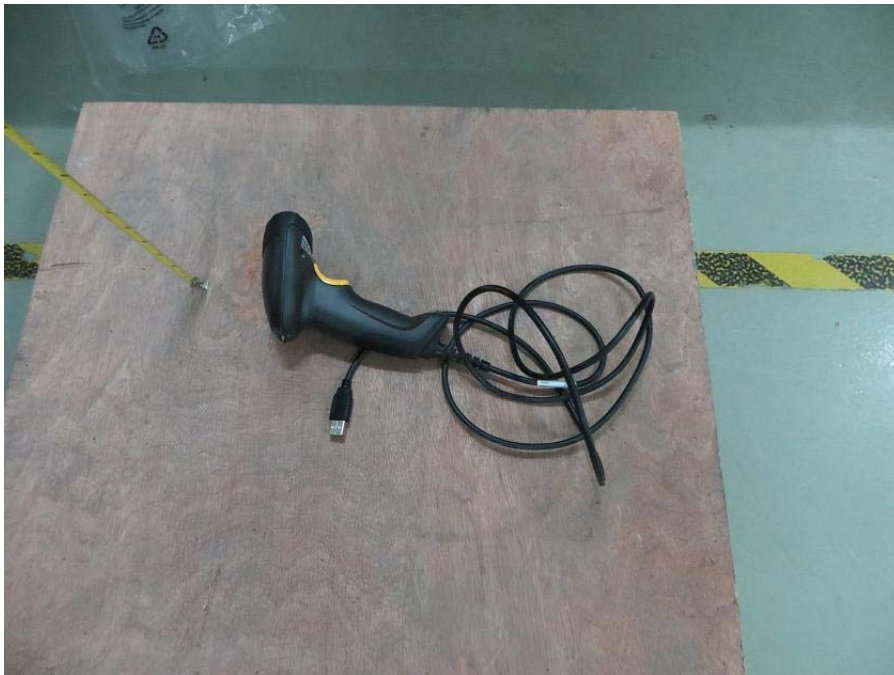
| Item<br>项目 | Test item<br>测试项目 | Standard requirement<br>标准要求 | Result<br>结果 |
|---|---|---|---|
| | Rear<br>后 | dropping from 1.8m<br>从 1.8 米处跌落 | No damage<br>没有危险 |

Fig.3 Test result of drop from Rear

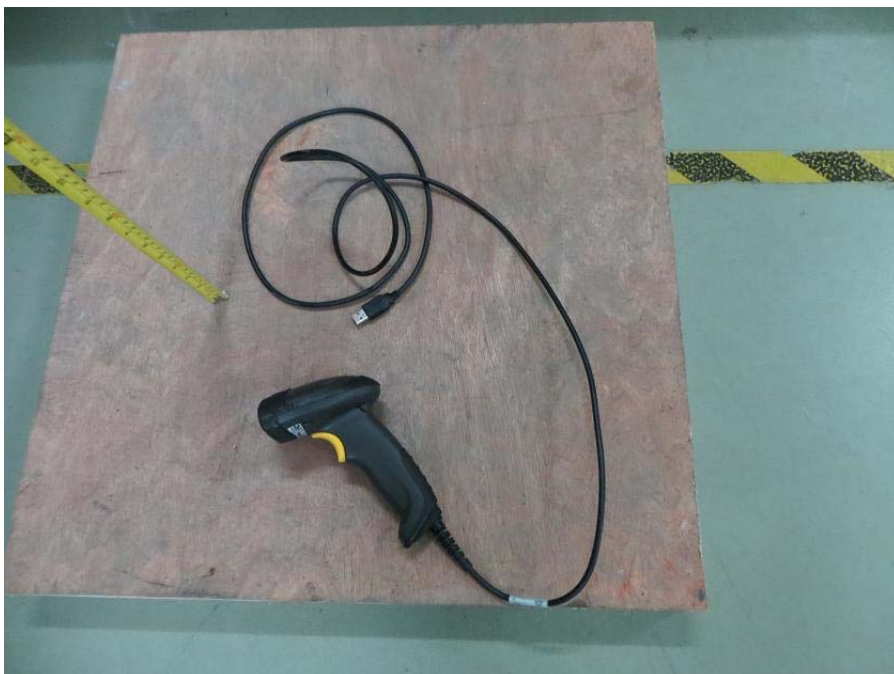
| Item<br>项目 | Test item<br>测试项目 | Standard requirement<br>标准要求 | Result<br>结果 |
|---|---|---|---|
| | Left<br>左 | dropping from 1.8m<br>从 1.8 米处跌落 | No damage<br>没有危险 |

Fig.4 Test result of drop from Left

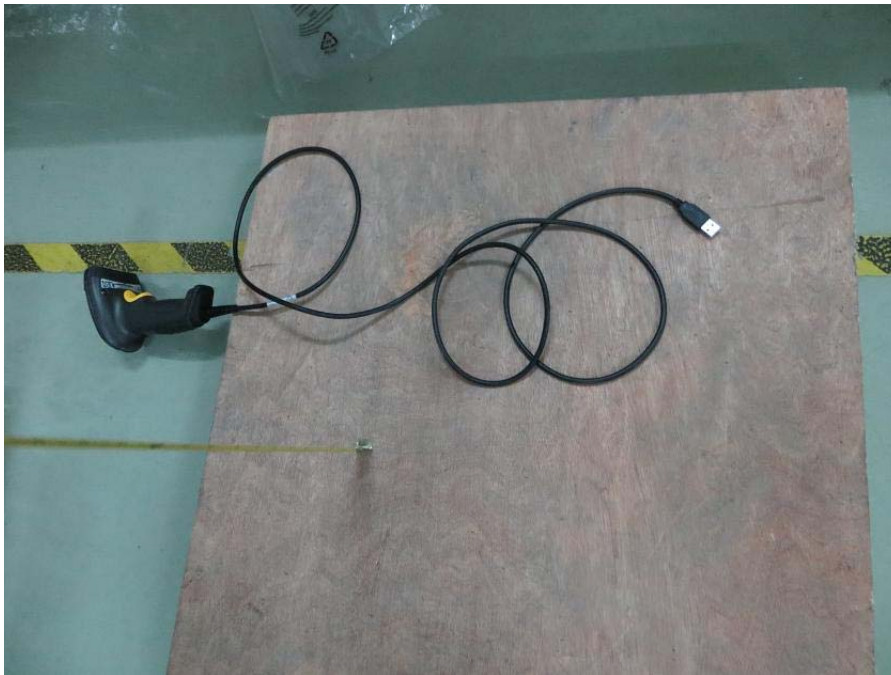
| Item<br>项目 | Test item<br>测试项目 | Standard requirement<br>标准要求 | Result<br>结果 |
|---|---|---|---|
| | Right<br>右 | dropping from 1.8m<br>从 1.8 米处跌落 | No damage<br>没有危险 |

Fig.5 Test result of drop from Right

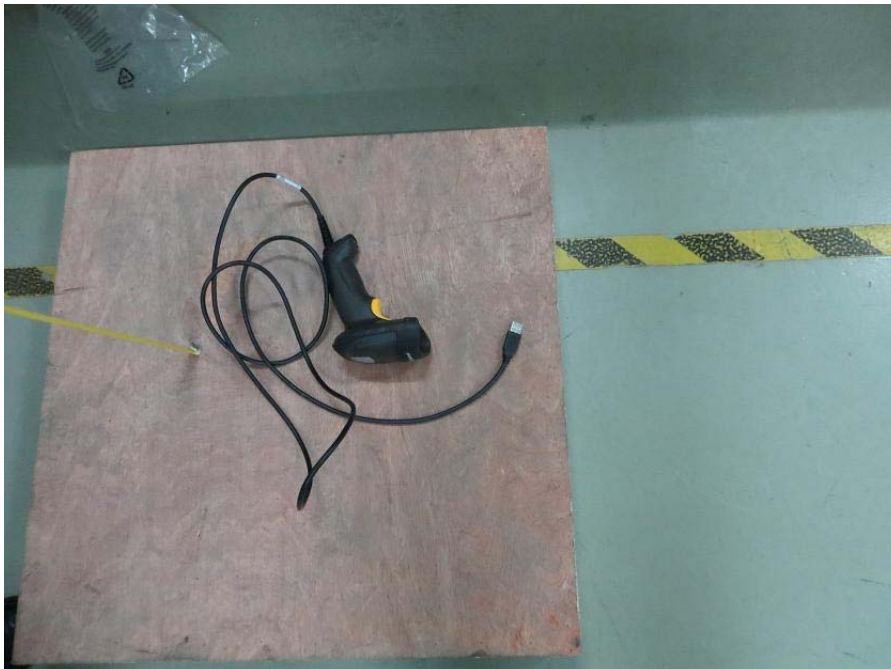
| Item<br>项目 | Test item<br>测试项目 | Standard requirement<br>标准要求 | Result<br>结果 |
|---|---|---|---|
| | Top<br>上面 | dropping from 1.8m<br>从 1.8 米处跌落 | No damage<br>没有危险 |

Fig.6 Test result of drop from Top

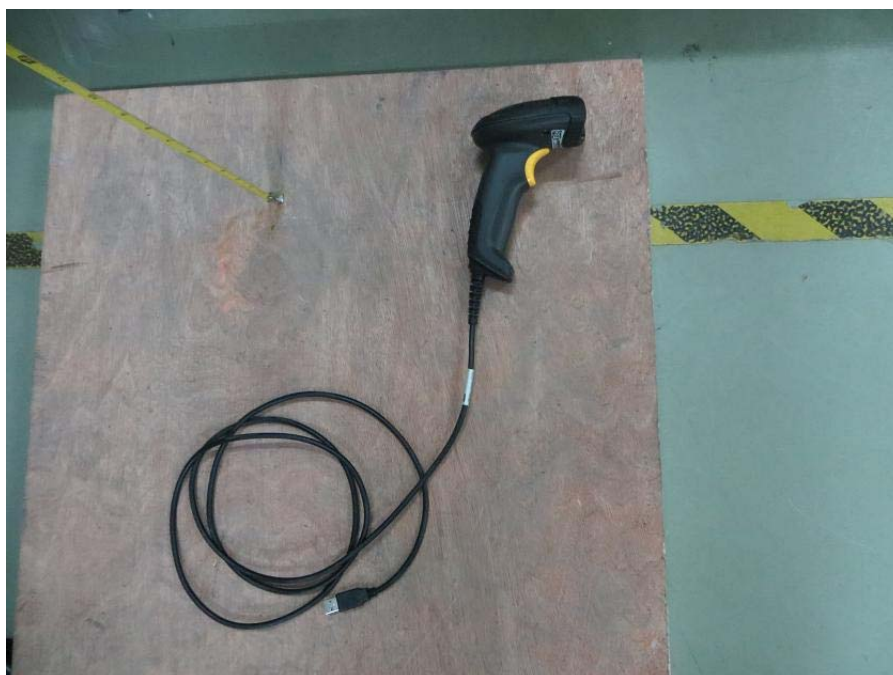
| Item<br>项目 | Test item<br>测试项目 | Standard requirement<br>标准要求 | Result<br>结果 |
|---|---|---|---|
| | Bottom<br>下面 | dropping from 1.8m<br>从 1.8 米处跌落 | No damage<br>没有危险 |

Fig.7 Test result of drop from Bottom
